Inspection - S.S. Tutshi - June 19, 1984

On June 19, Mr. Alex Barbour, senior engineer, Restoration Services Division, Parks Canada inspected the S.S. Tutshi located in Carcross, Yukon. Mr. Barbour's one day "bottom to top" inspection gave us a general idea of the Tutshi's structural condition, presence of wood deterioration and measures to ensure protection against public impact and weathering.

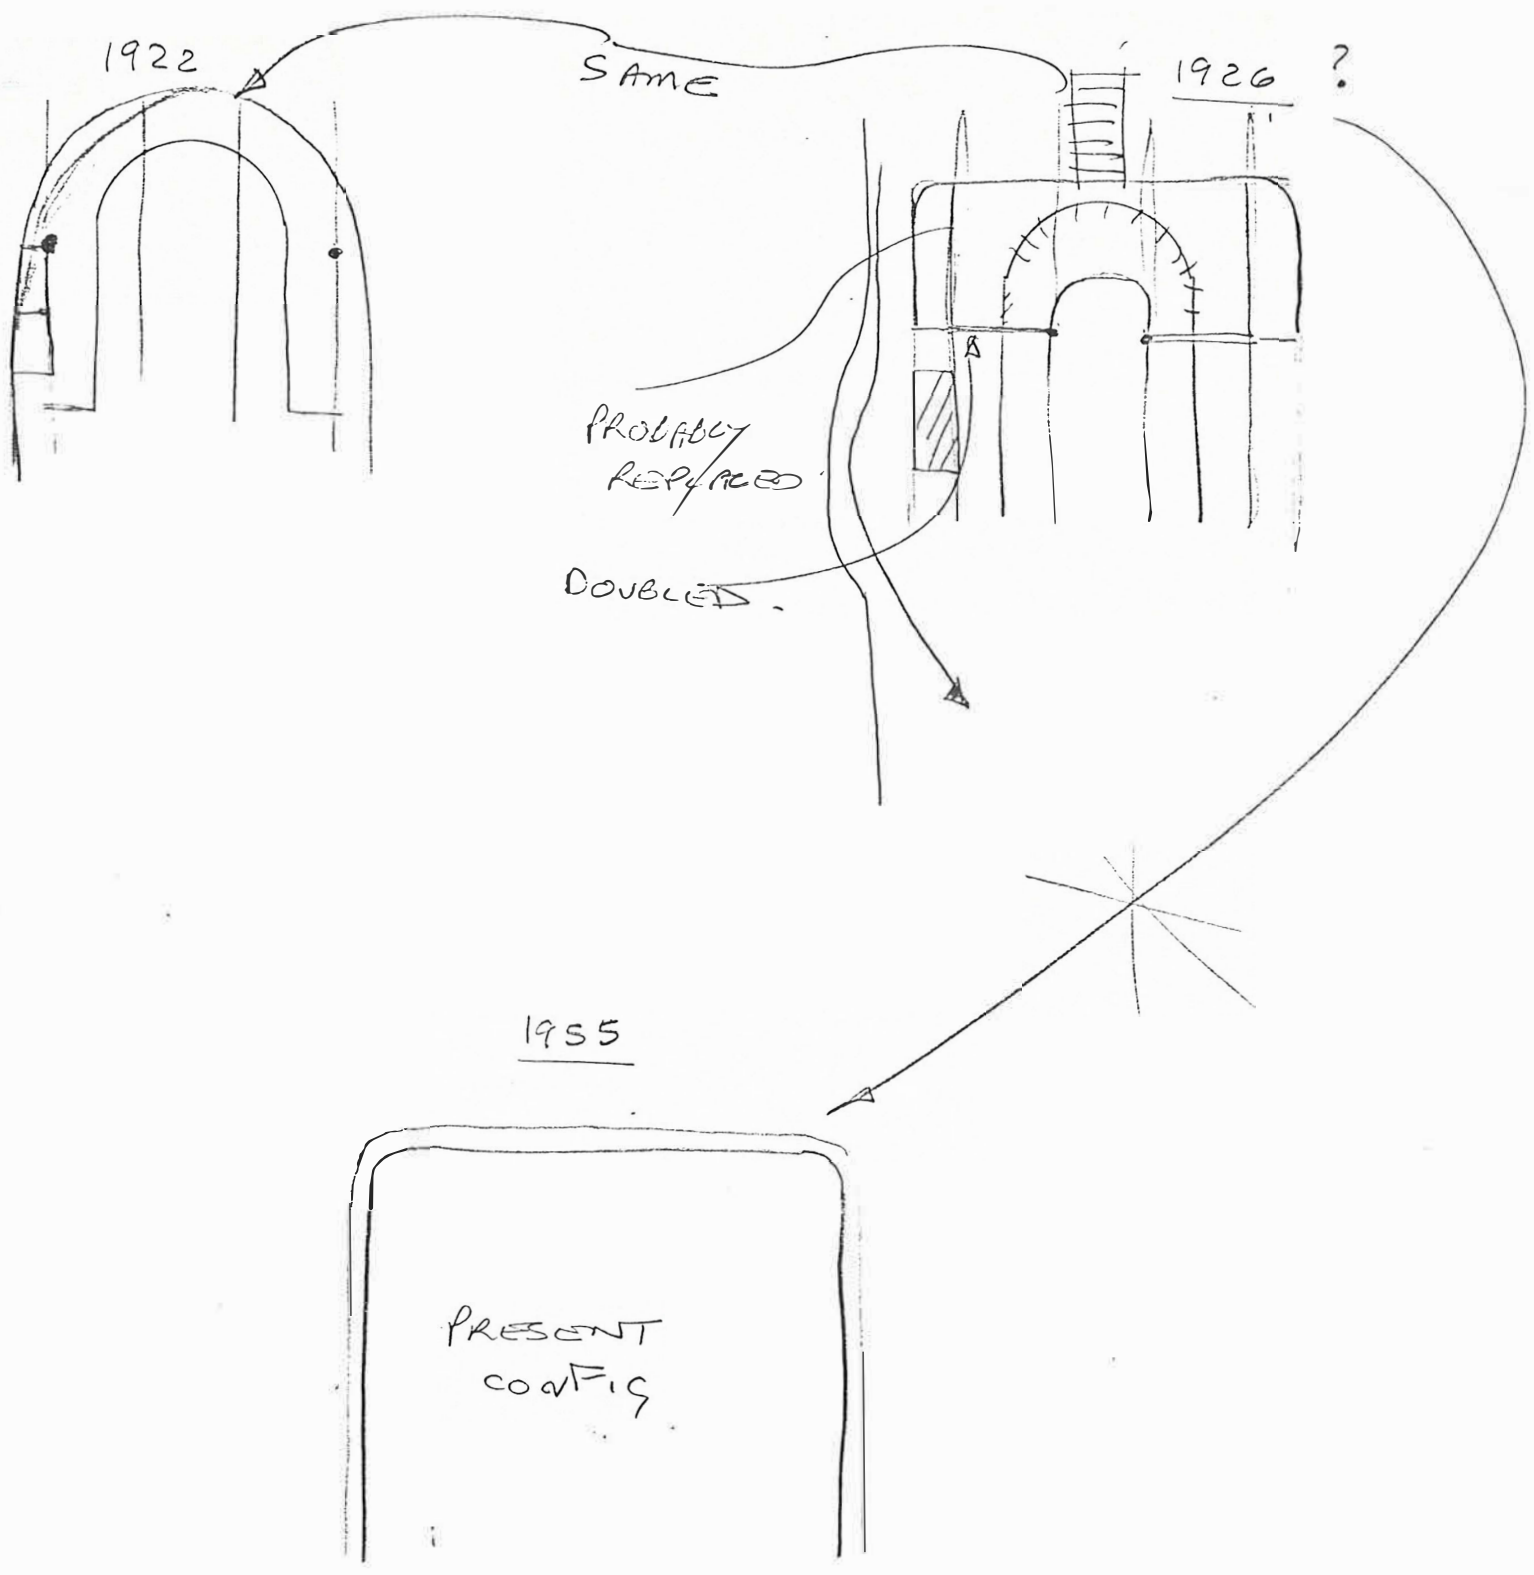
1924

1922

1926 ?

PROBABLY  
REPLACED

DOUBLED

1955

PRESENT  
CONFIG

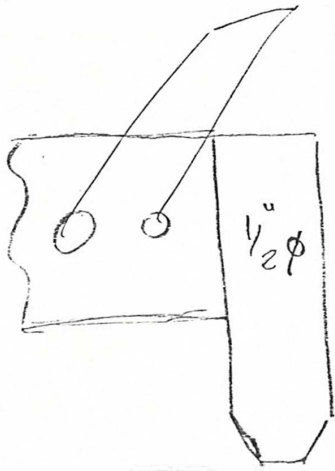
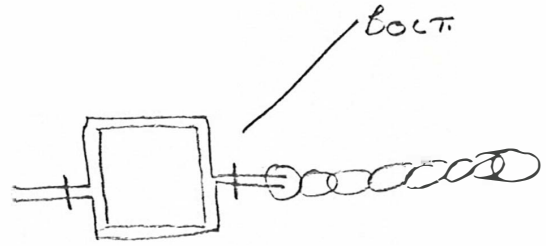
BOLTS TO RAILS.

3" + 4" DEEP ON BOTTOM.

- chain and post for freight deck railing - see drawing by Alex
